ADIGUDEM SURFACE IRRIGATION PROJECT (GUMSELASA DAM, Northern Ethiopia)

This document describes how the Irrigation infra- structures of Adigudem project was constructed.

*Date of construction:
Feb 1996 – Nov 1996*

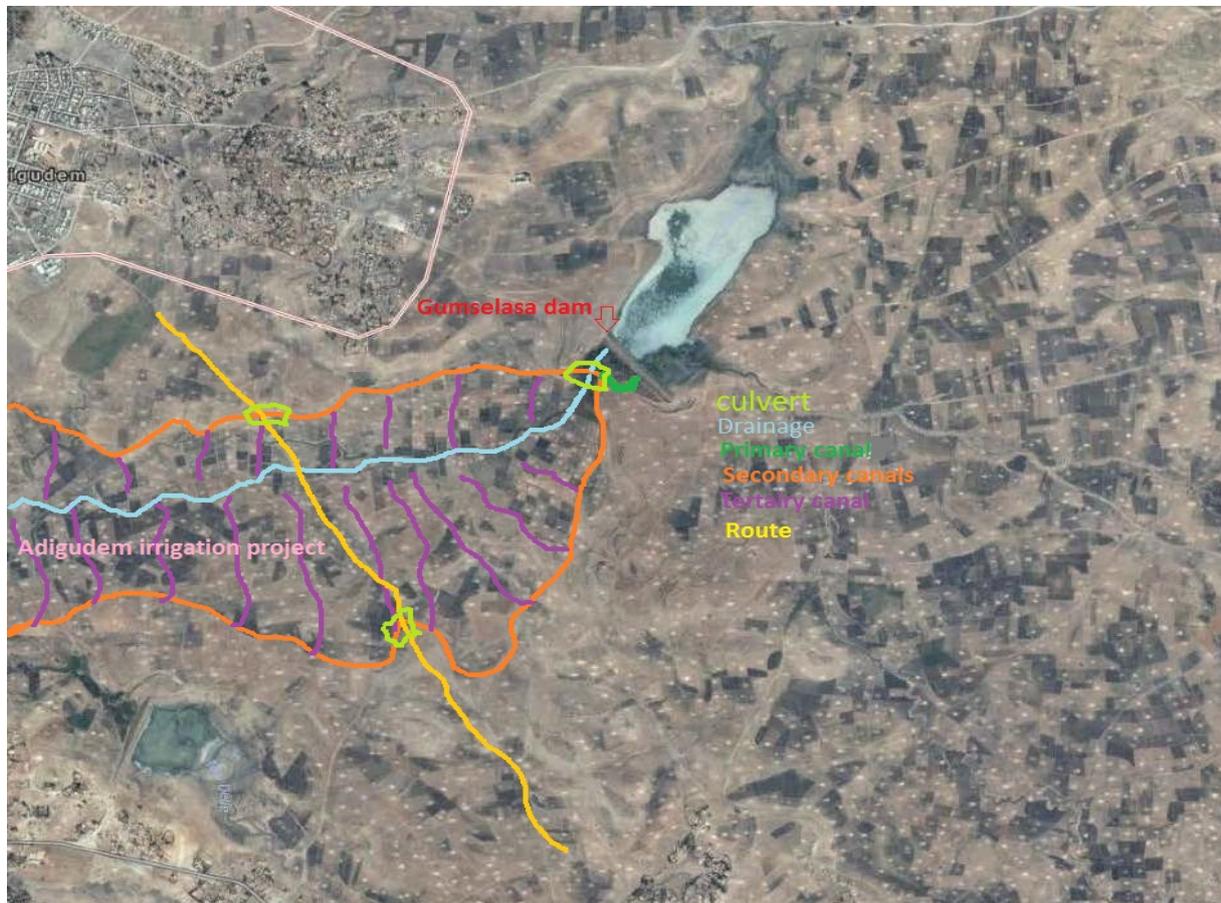
In 1996, the Adigudem dam had already been completed and the next assignment was to construct the irrigation canals below the dam. Figure 1 shows Adigudem surface irrigation project (GumSelasa Dam).

Figure 1 Adigudem Surface Irrigation Project (GumSelasa dam), Tigray, Ethiopia

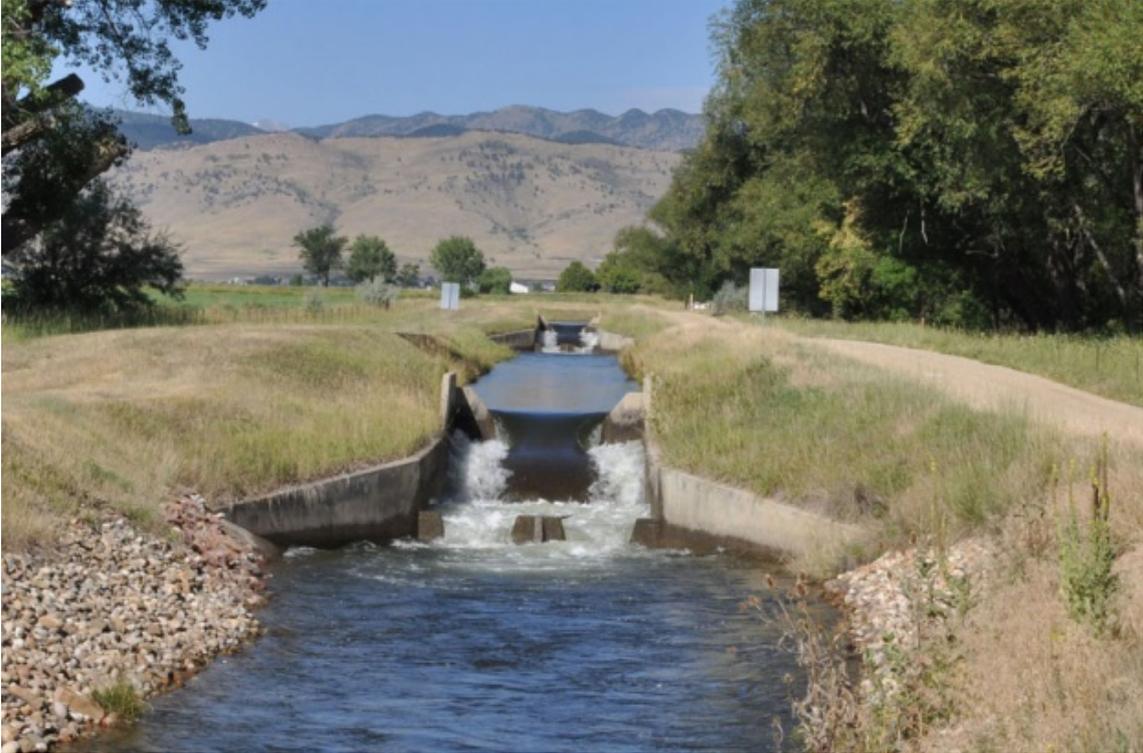
Figure 2 helps to conjure up the drop structure constructed at the Adigudem site. The image presented here is not the actual picture taken at the Adigudem irrigation site but a portrayal to visualize the structures constructed at the project (similar to these drop structures).

Figure 2 Drop structure on Boulder Feeder Canal, NorthernWater.org

The canals incorporated 400 concrete drop structures (canal falls) with a size of around 1-1.7 m height and 90-1.20cms width and 0.3m thickness. The downstream and upstream side of the drop

structures have actually simple stone aprons (without mortar). There were two large drop structures with stilling basins at the downstream side and concrete apron at the upstream side.

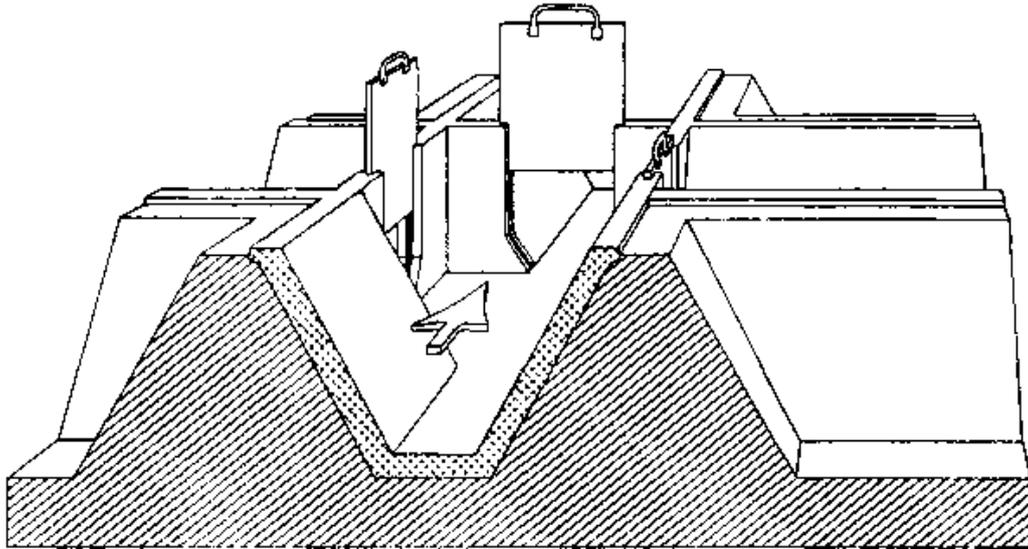
There were several turnouts (diversion boxes with small gates) at the junction of secondary and tertiary canals. An illustration of the division box shown in Figure 3 and 4 utilized to demonstrate the actual turnout at the project.

Figure 3 Division box /turnout (FAO)

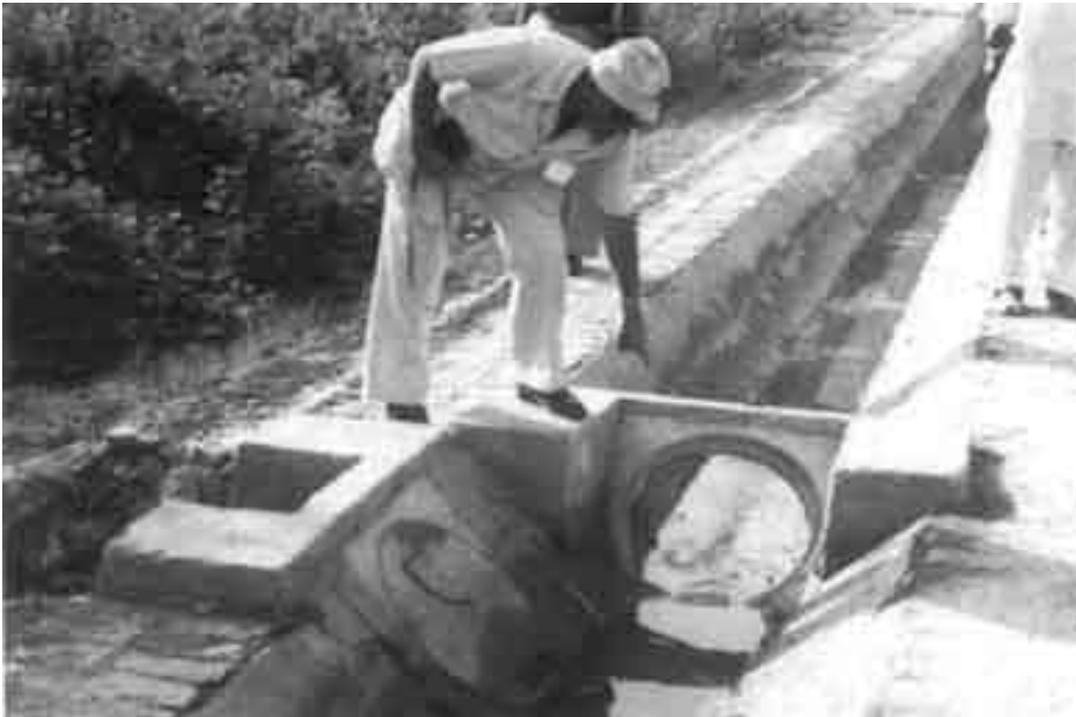
Figure 4 Turnouts FAO

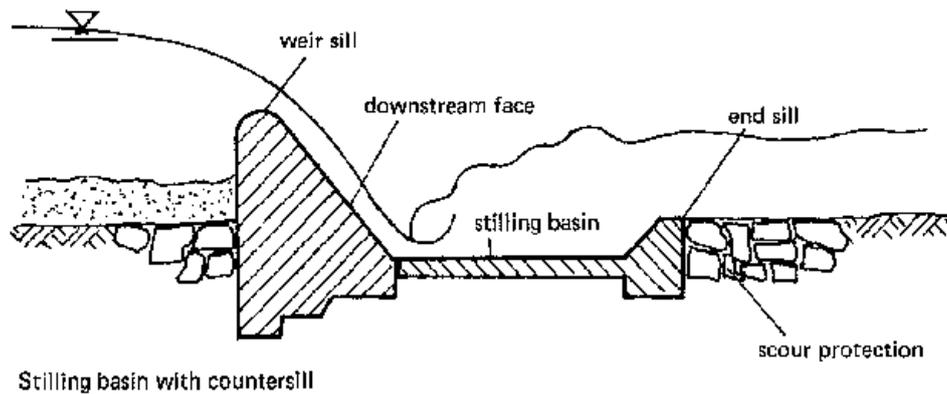
There were two Large drop structures that have stilling basin with an approximate size of 3m* 2m*0.4m. Figure 5 shows a typical example of a stilling basin.

Figure 5 Typical example of a stilling basin (www.nzdl.org)

Grand drop structure with stilling basin: 2, (~size 3m* 2m*0.4m)
